FTC-TR-72-7

CATEGORY II SYSTEMS FOLLOW-ON TESTS OF THE HH-53C HELICOPTER

TECHNICAL REPORT No. 72-7
FEBRUARY 1972

AIR FORCE FLIGHT TEST CENTER
EDWARDS AIR FORCE BASE, CALIFORNIA
AIR FORCE SYSTEMS COMMAND
UNITED STATES AIR FORCE

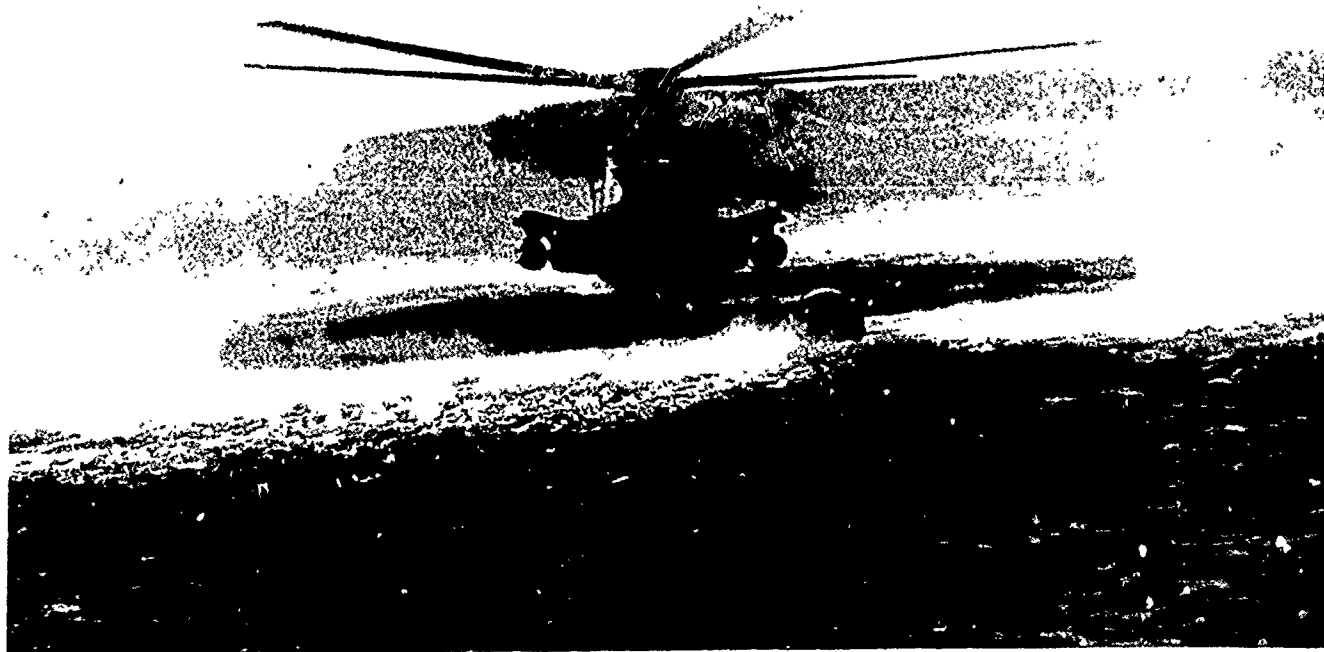
Figure I Five-Foot Hover Height

Three flights were made in the environmental conditions of a sea state of one and winds ranging from zero to 5 knots. Some spray was ingested as the helicopter came to a hover. After becoming established in a 5-foot hover, the rotor downwash continued to blow the salt spray away from the helicopter and engine inlets. Under these conditions the engine inlets and the windshield remained dry. No measurable engine power deterioration was experienced under these conditions. Based on the results of the 57-minute flight 4 (table II) it was determined that hover operations at any altitude over salt water with wind conditions of 5 knots or less can be safely conducted for at least 2 hours without a complete loss of engine power margin. This applies with or without EAPS.

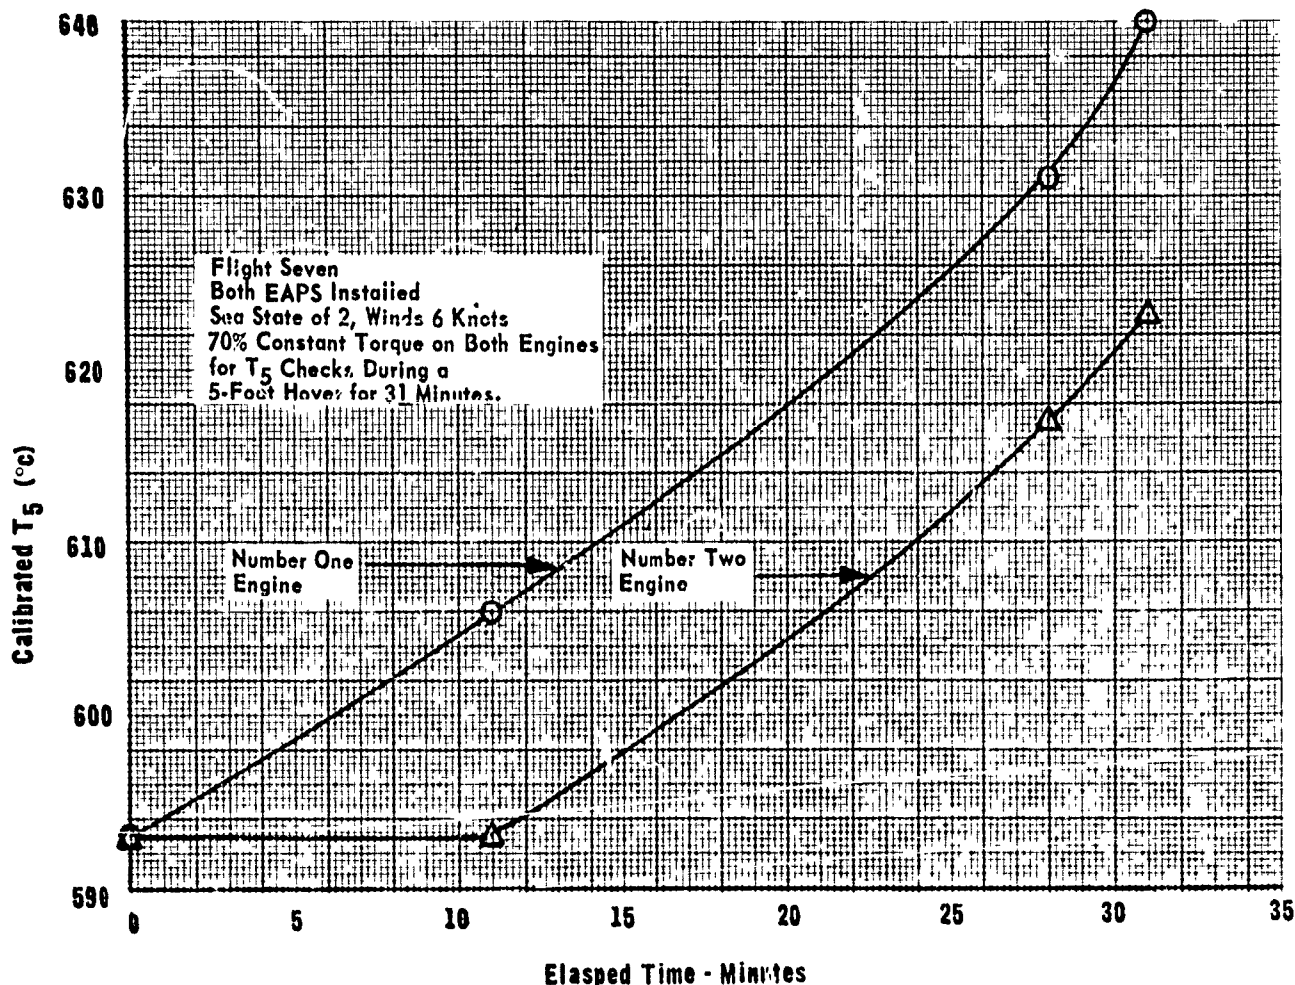
Figure 3 Effect of Salt Spray Ingestion on Power Turbine Inlet Temperature

ingestion with respect to hover time. These figures show data taken with EAPS installed on both engines. It was also observed, during winds of 5 to 6 knots, that the counterclockwise rotation of the main rotor blades caused more spray to impinge on the left side of the aircraft. This would indicate that the left hand engine ingested more salt spray over a given period of time than the right hand engine and explains the more rapid rise in T_5 for the left hand engine.
